# Manhole Inspection Summary

Manhole # S29EE2020MH

Insp Date: **12/21/06 11:26 AM**

**Location** Address: **2 MELROSE AVE**

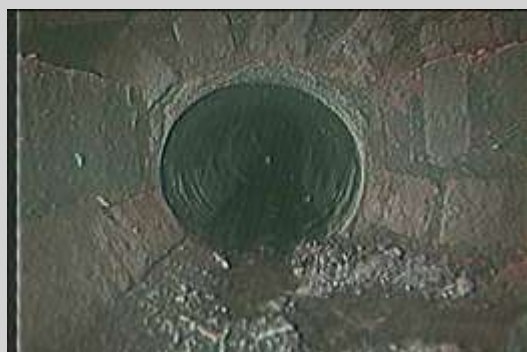
Pipe Out @ 12 O'Clock

### 8 in. Circular Gravity Sewer

Pipe Material: **Clay** ☐ Pipe Lined

Invert Depth: **9.37** (ft.) Flow Characteristics: **Slow**

Infiltration: **None** Pipe Seal Cond: **Unknown**

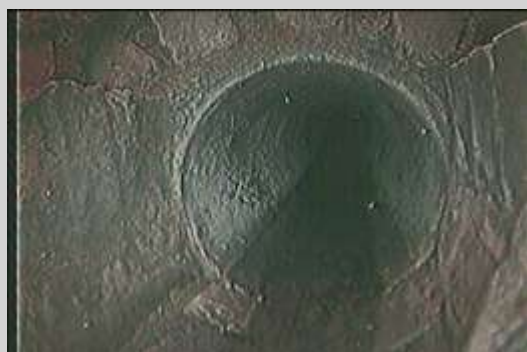
Pipe In @ 3 O'Clock

### 8 in. Circular Gravity Sewer

Pipe Material: **Clay** ☐ Pipe Lined

Infiltration: **None** Pipe Seal Cond: **Unknown**
